Structure of microfiche

E16	Product/component/test step
	Vehicle/engine

Trouble-shooting program

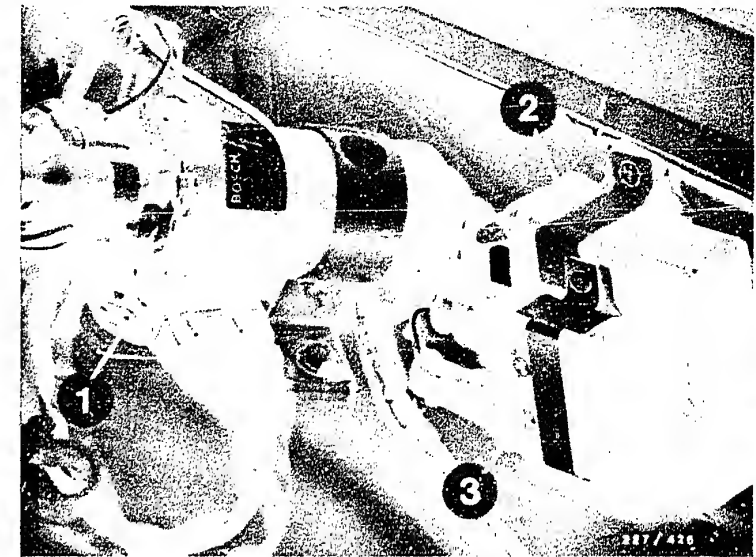
Press timing-advance unit plug detent in direction of arrow, then pivot plug in direction of arrow. See bottom picture.

To disconnect the timing-advance unit plug, it is necessary to remove battery and timing-advance unit.

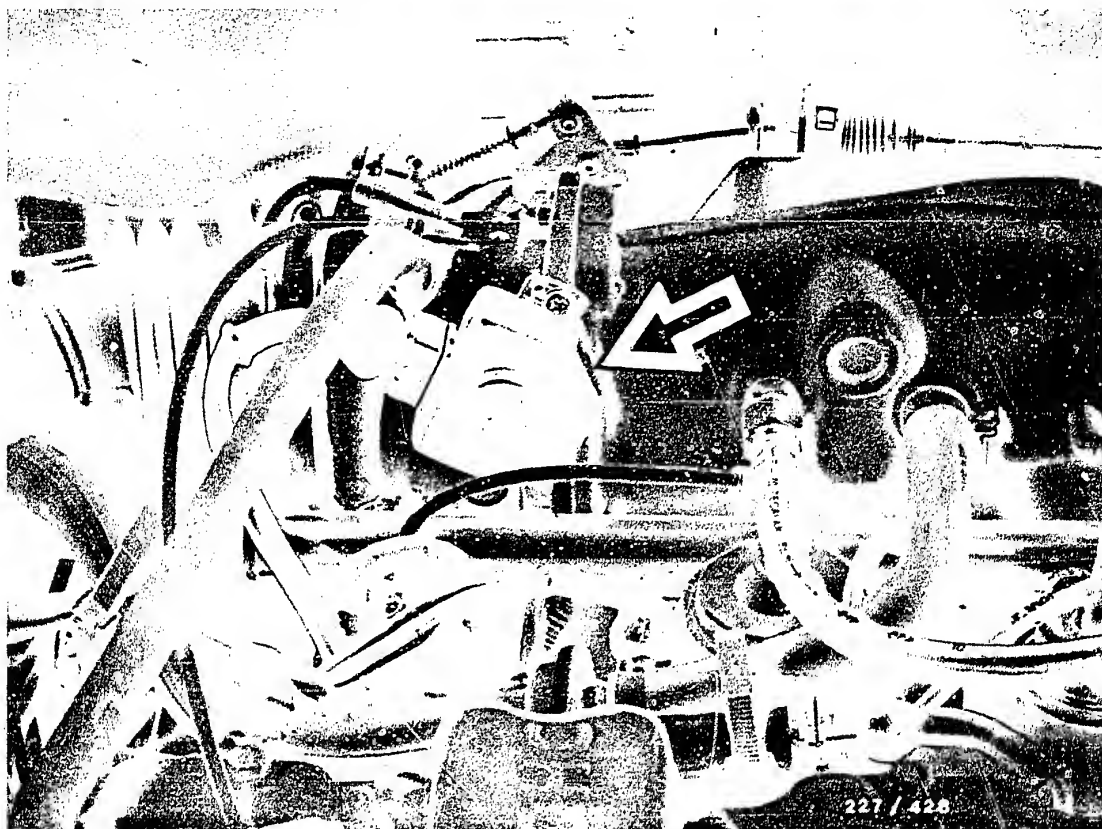
Arrow = Throttle-valve switch

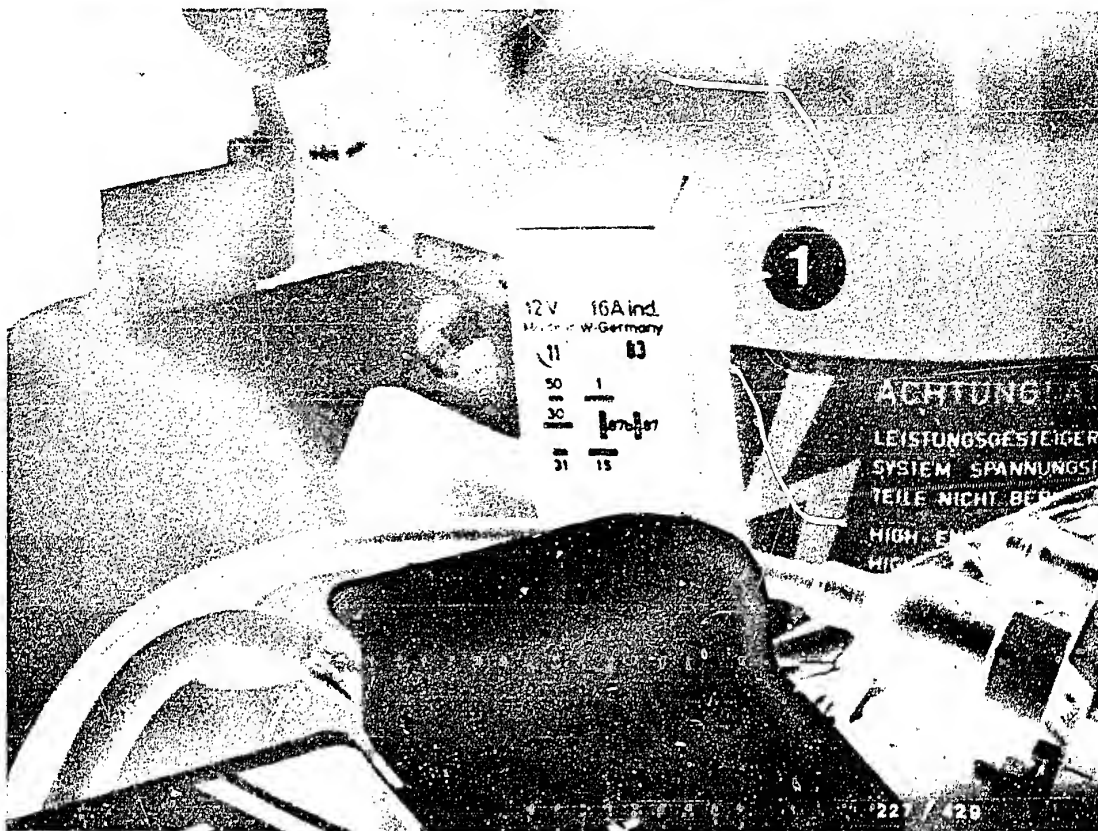
1 = Control relay for L-Jetronic - version LE 2

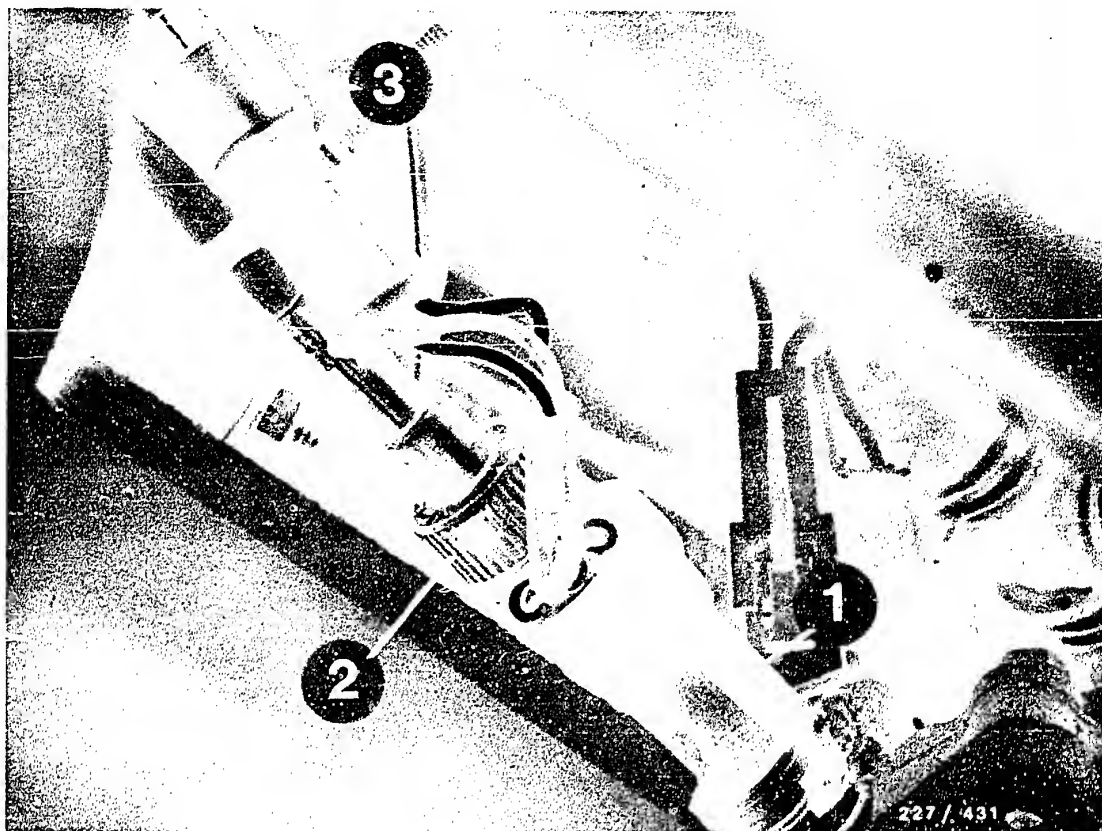
- 1 = Distance pulse generator
- 2 = Speedometer shaft connection
- 3 = Distance pulse generator plug

The distance pulse generator is situated at the speedometer shaft connection (transmission). See picture.

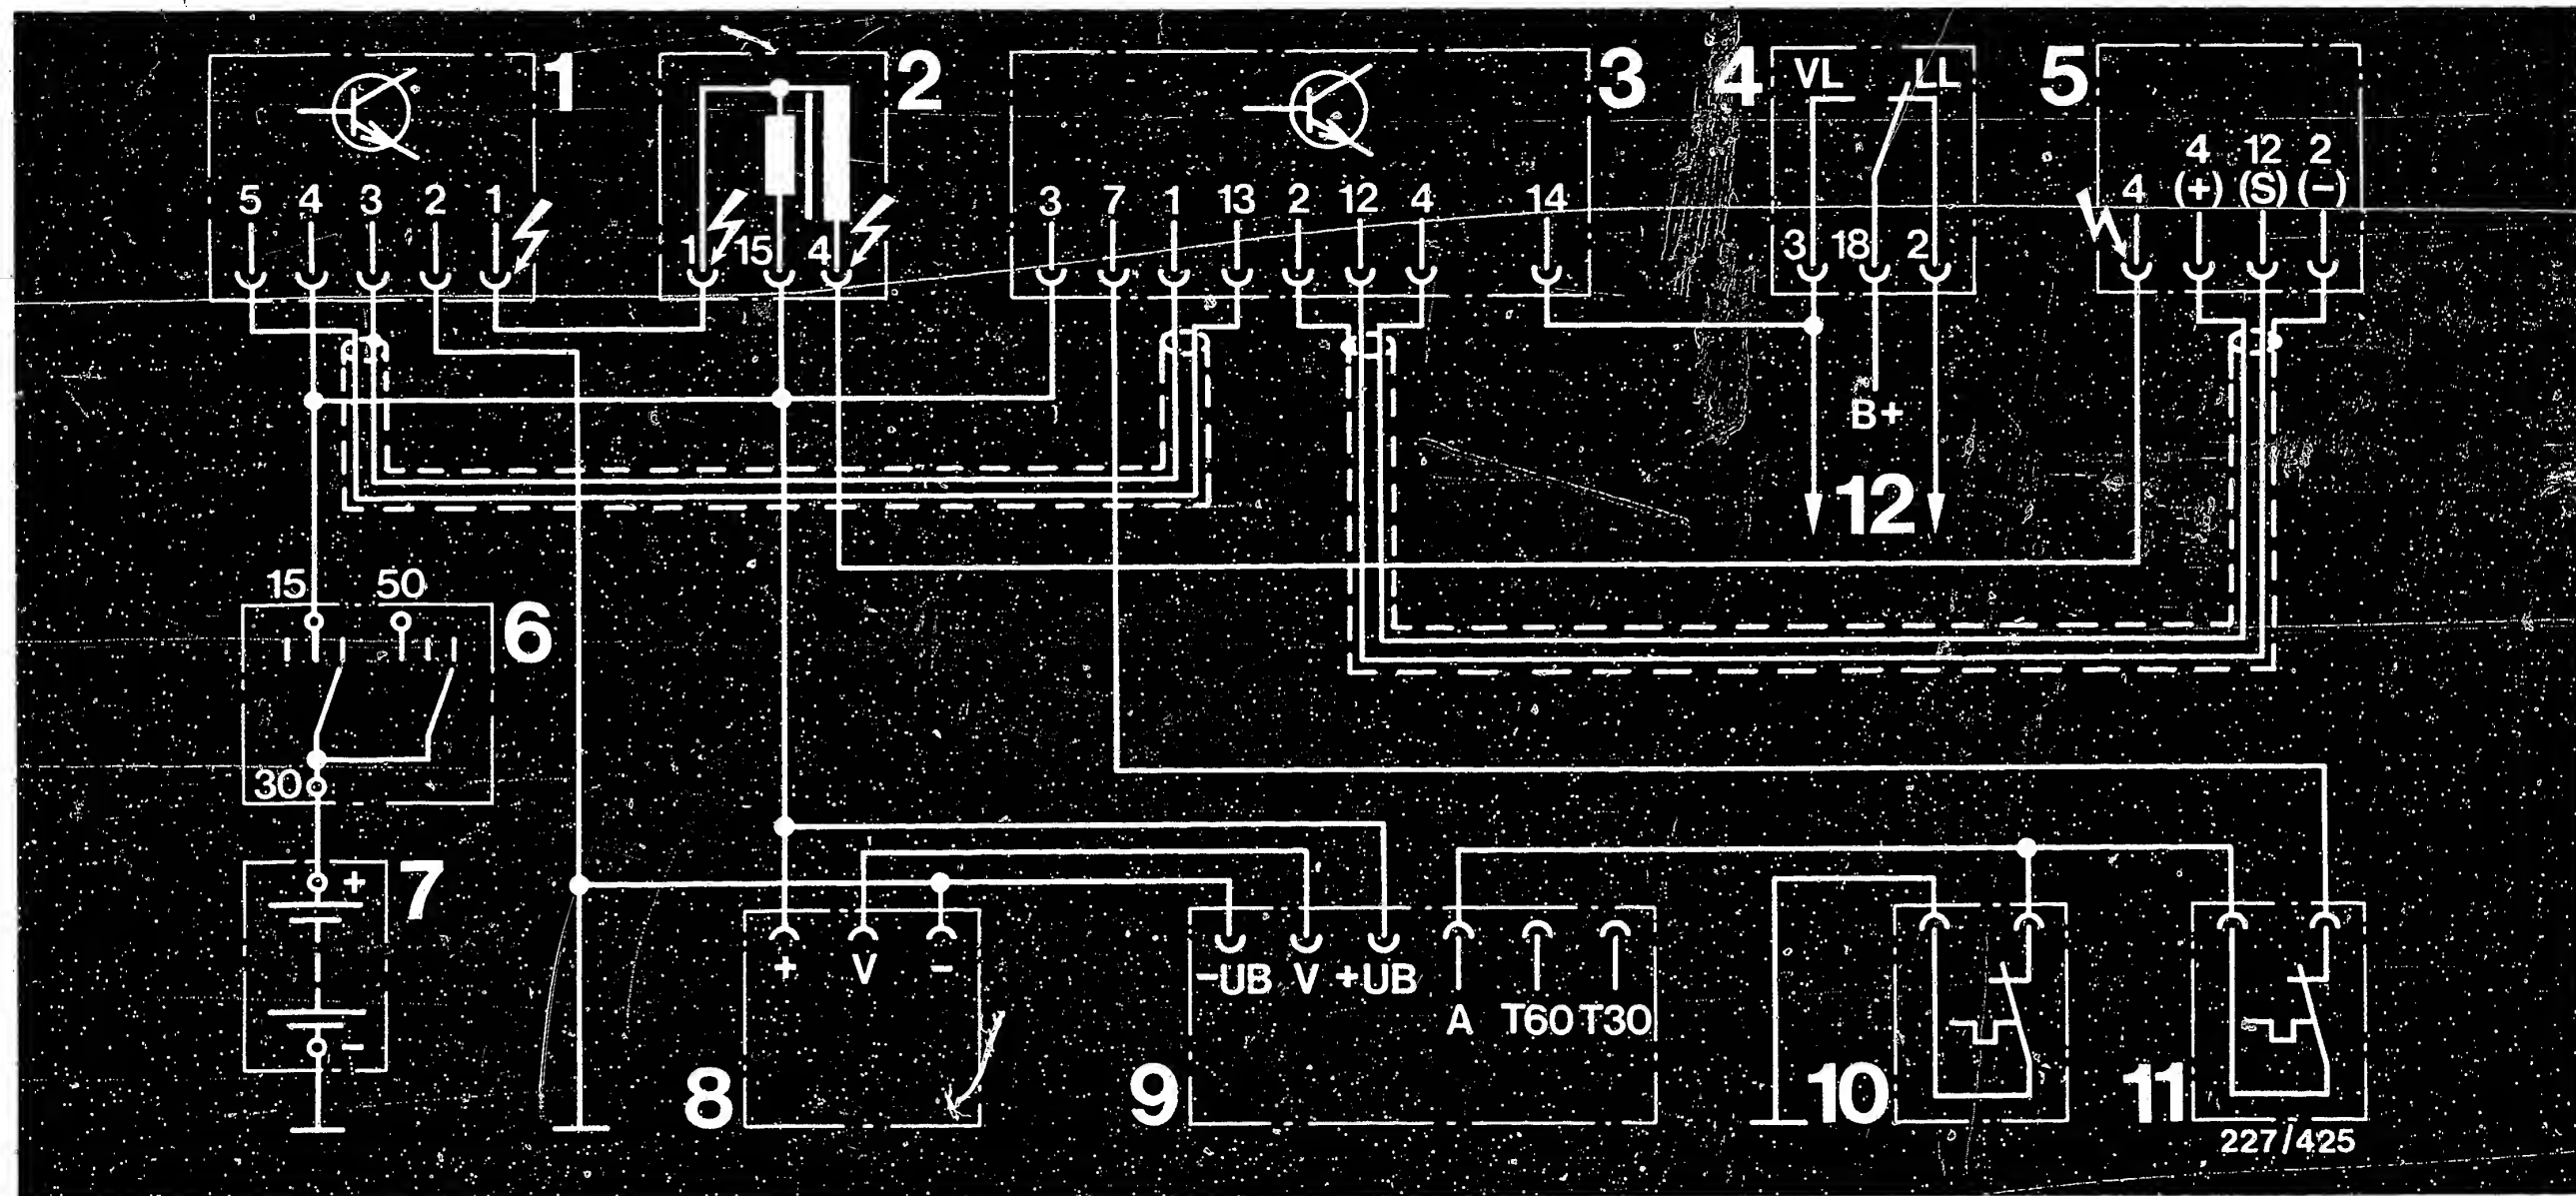
⚡ = Dangerous voltage
(400 V - 25 kV)

1 = Trigger box
2 = Ignition coil
3 = Timing-advance unit

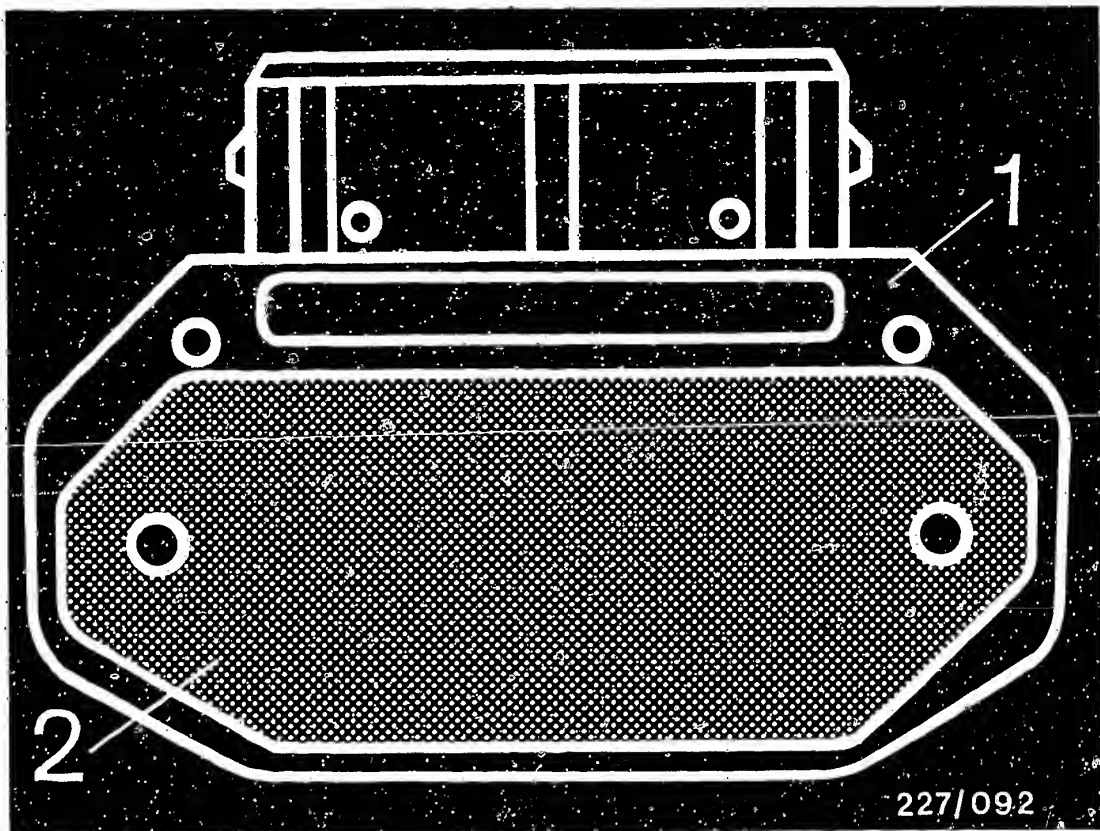
1 = Trigger box

2 = Base plate

Do not apply thermal conduction paste to painted parts.

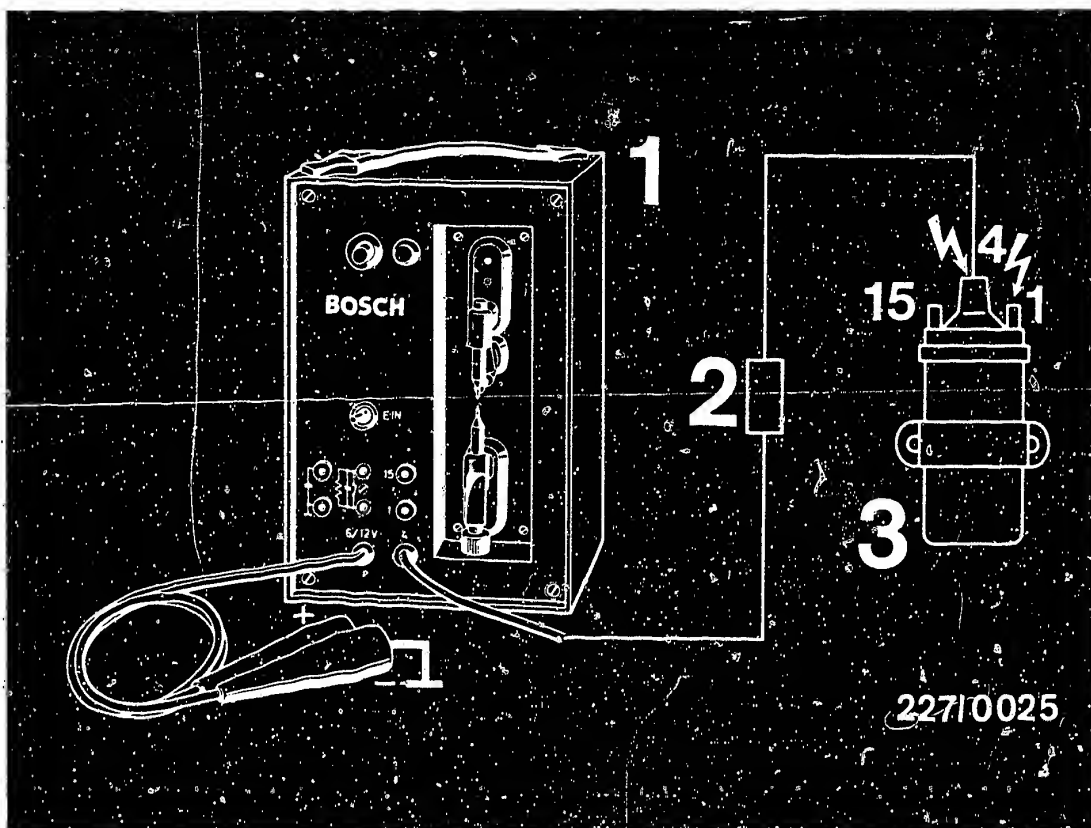
- 1 = Spark gap
- 2 = 5 k Ω sleeve-type suppressor
- 3 = Ignition coil

- In order to prevent the trigger box from being irreparably damaged, when using a spark gap, an interference-suppression resistor of at least 2 k Ω must be connected between the spark gap and ignition coil terminal 4, e. g. sleeve-type suppressor (5 k Ω) 0 356 500 001.

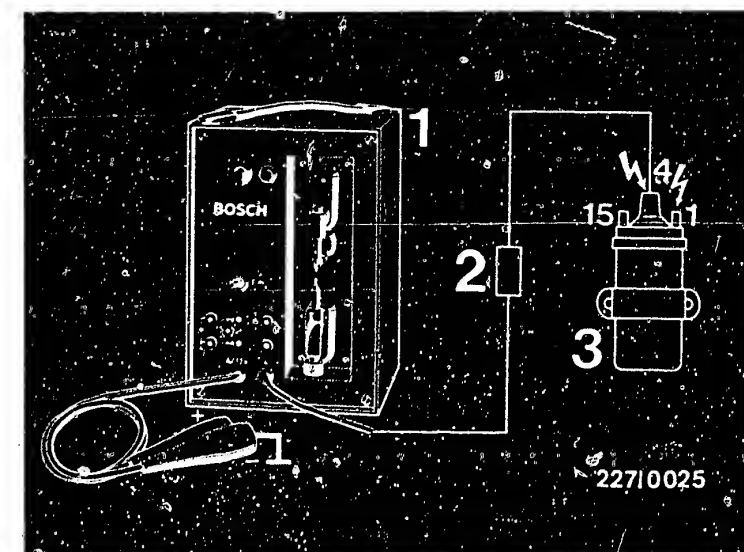
1 = Spark gap
2 = 5 k Ω sleeve-type suppressor
3 = ignition coil

⚡ = dangerous voltages
(400 V - 25 kV)

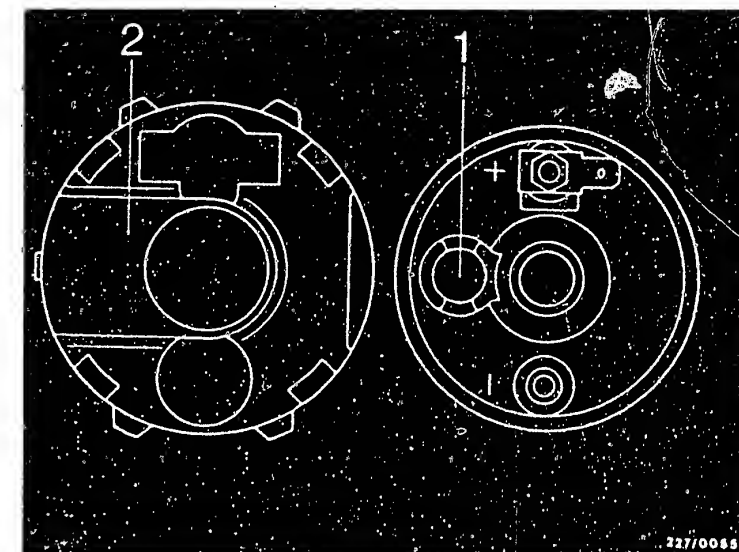
1 = Plug
2 = Protective cap

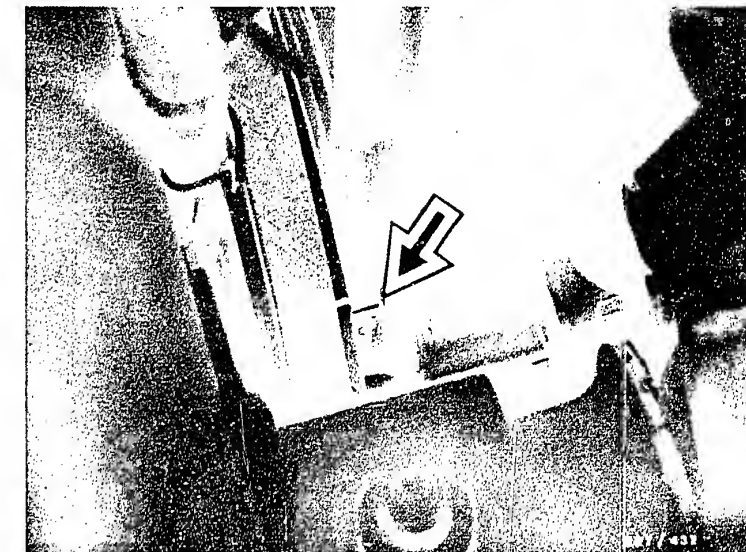
Arrow = Ignition timing mark
(8° BTDC)

Loosen ignition-distributor mounting and turn ignition distributor until marks align. (10° BTDC).

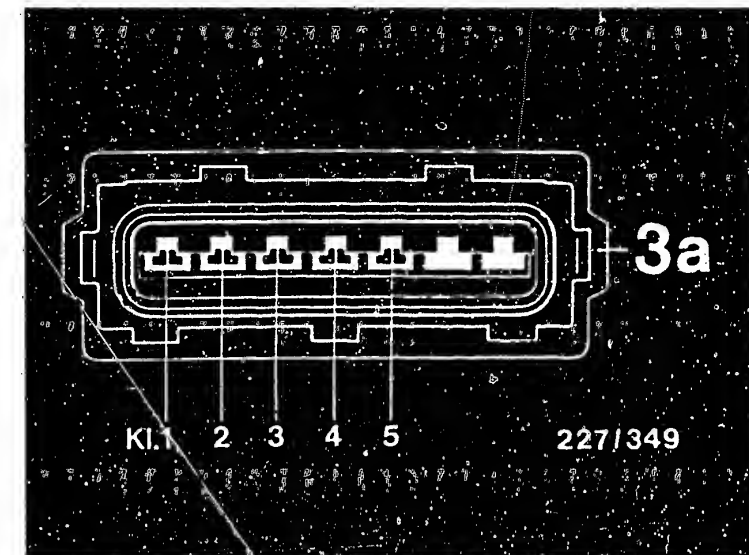
3a = Trigger-box plug

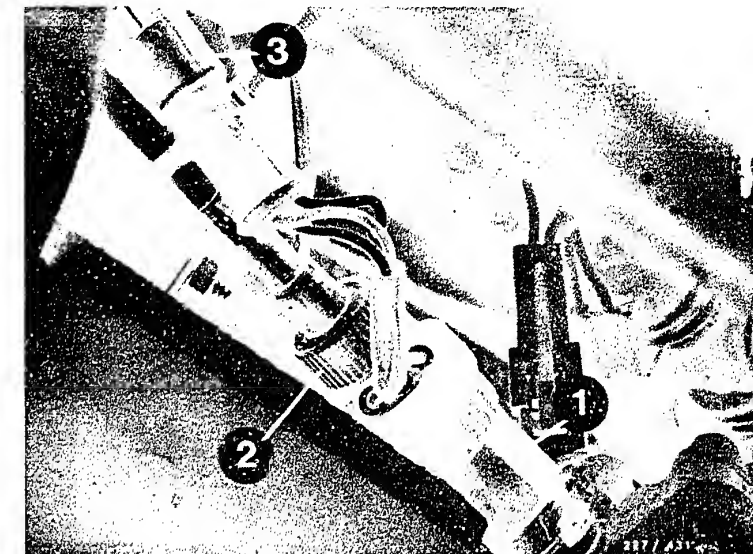
1 = Distance pulse generator
2 = Speedometer shaft connection
Arrow = Distance pulse generator plug

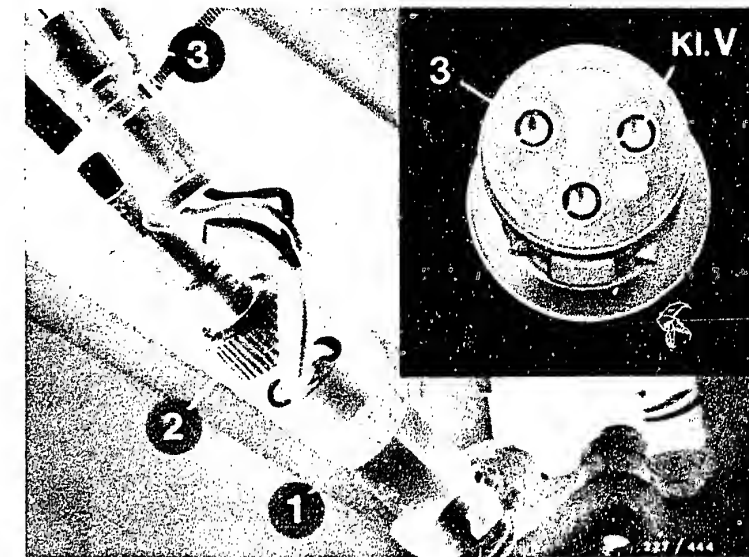
- 1 = Distance pulse generator
- 2 = Speedometer shaft connection
- 3 = Distance pulse generator plug

If dwell angle reading not O.K.,
test for open circuit in lead from speed switch
plug term. V to distance pulse generator plug
term. V.
Eliminate open circuit.

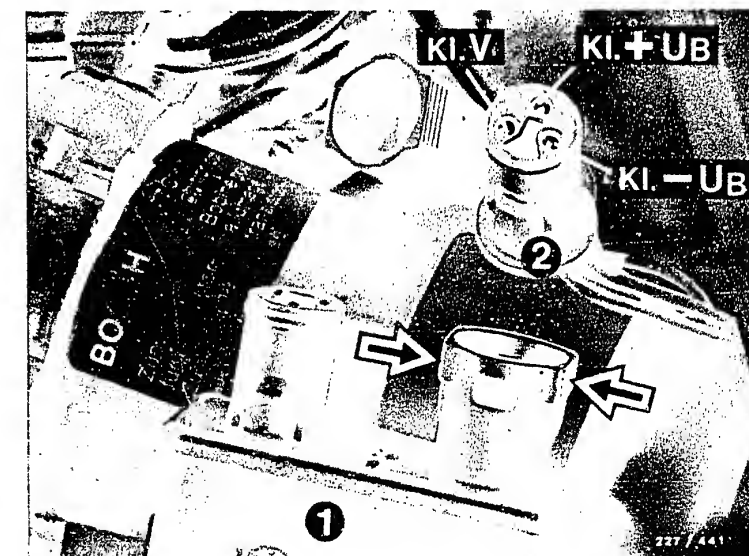
- 1 = Speed switch
- 2 = Speed switch plug

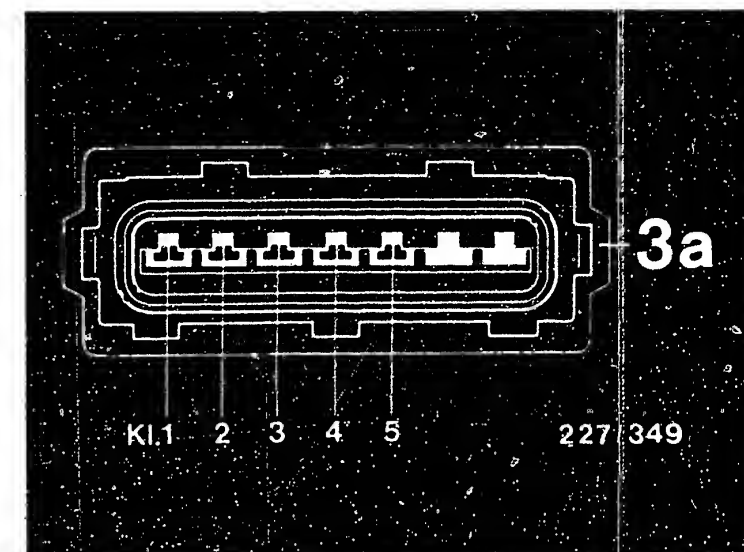
3a = Trigger-box plug

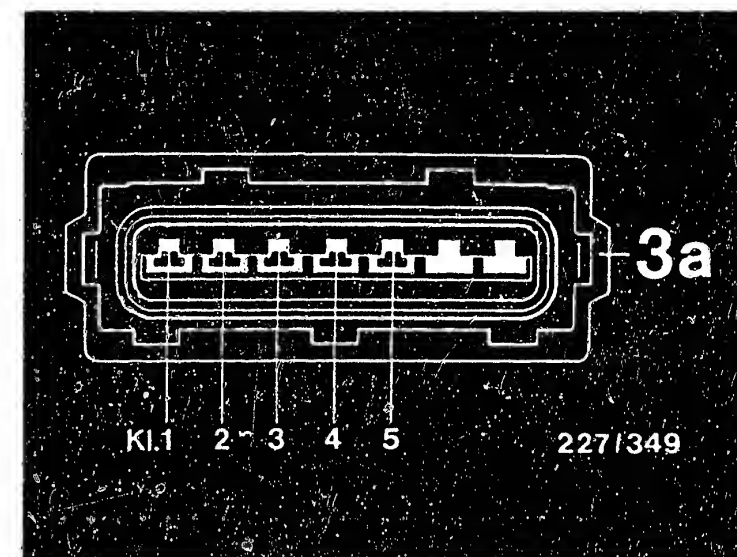
D1

3a = Trigger-box plug

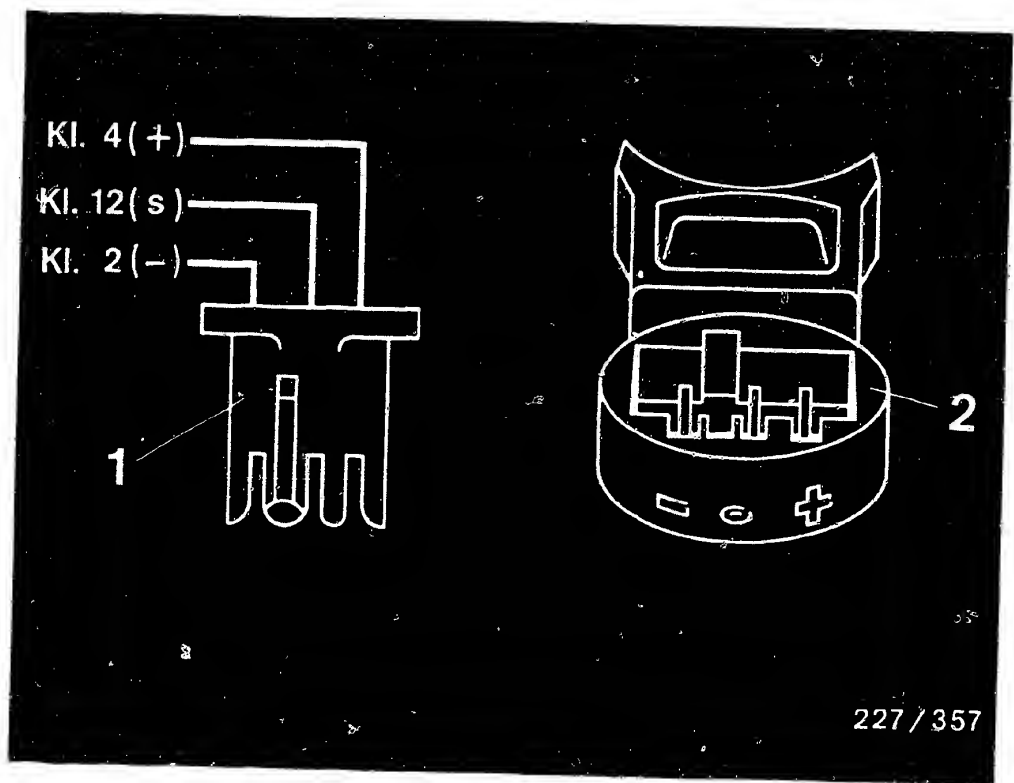
1 = Ignition-distributor connector
2 = Ignition-distributor socket

Remove the ignition-distributor connector (see picture) and check contacts for oxidation and correct latching (remedy defects).

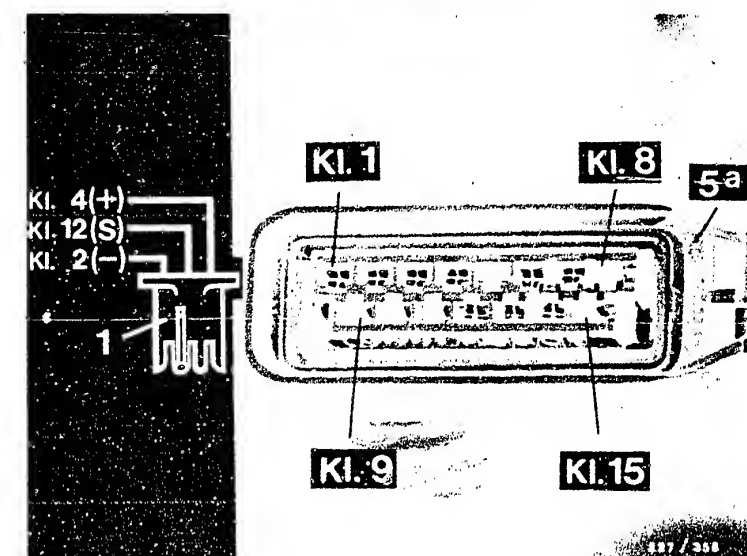
1 = Ignition-distributor connector
5a = Ignition timing unit plug

3a = Trigger-box plug

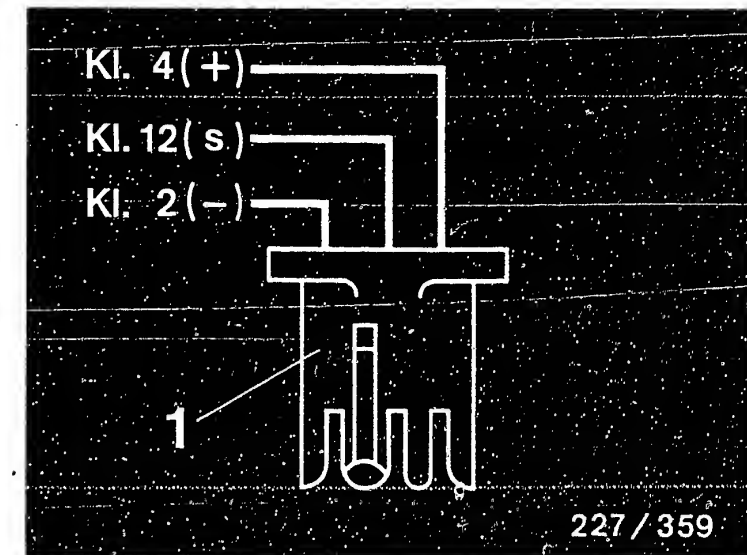
1 = Ignition-distributor connector

Rectangular pulse

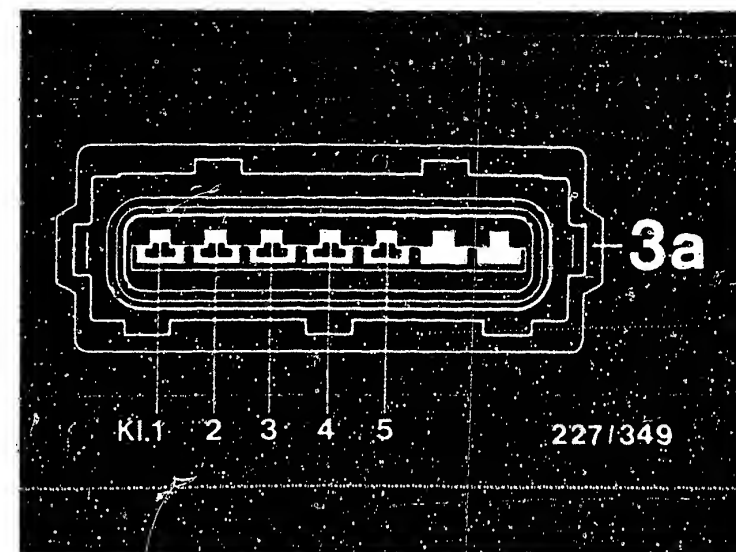
3a = Trigger-box plug

Rectangular pulse

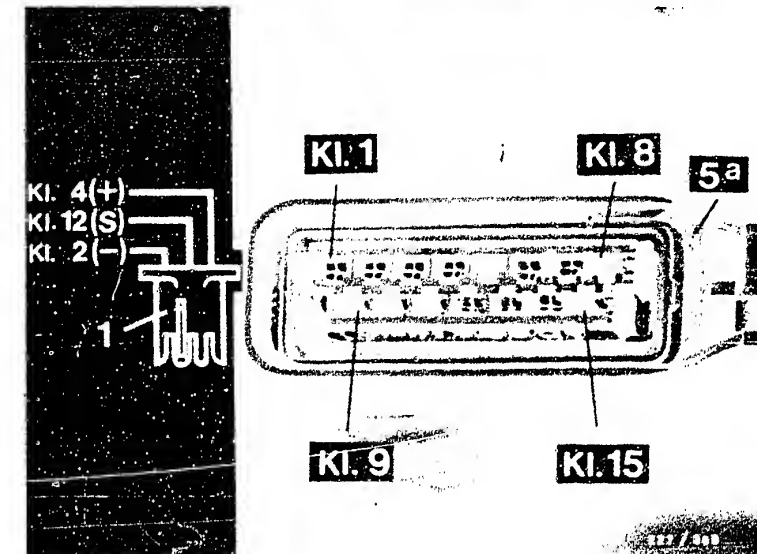
1 = Ignition-distributor connector
5a = Ignition timing unit plug

3a = Trigger-box plug

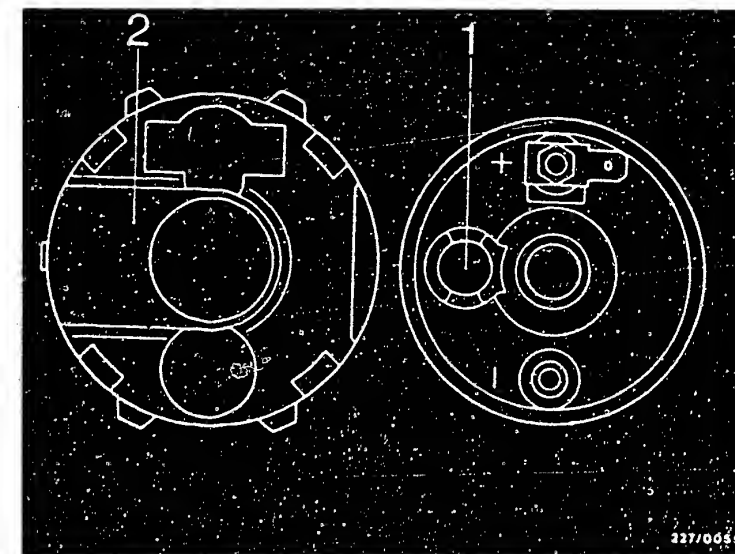
1 = Plug
2 = Protective cap

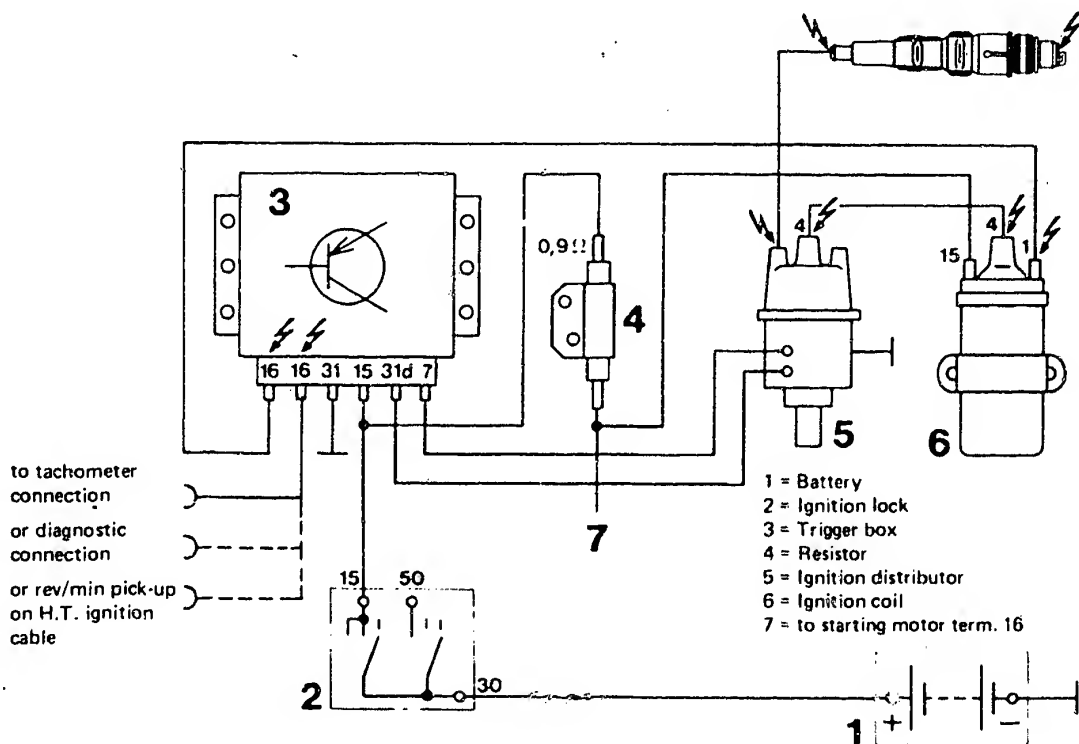
Terminal diagram

Below is a typical terminal diagram of a semi-conductor ignition system, the danger points are marked with red high-voltage arrows. We would point out that all semi-conductor ignition systems, even the older ones, are to be regarded as dangerous in the sense as defined by this bulletin.

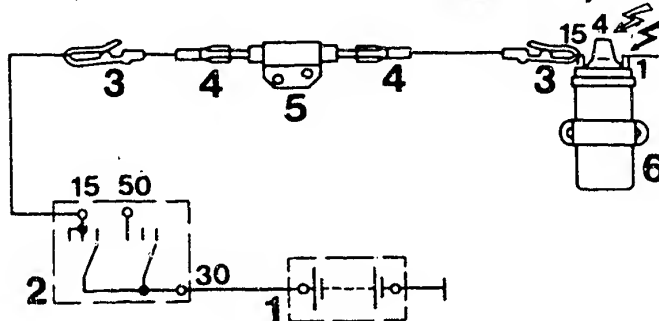
Connect a ballast resistor of 0.9 or 1.0 Ohm (see Fig.) in series in the line to term. 15 of the ignition coil (take care not to cause a short circuit). After the rotational-speed measurement, the ballast resistor must be removed (otherwise starting difficulties and misfiring). Connect tester as per operating instructions.

- 1 = Battery
- 2 = Ignition switch
- 3 = Clips

- 4 = Blade receptacle
- 5 = Ballast resistor
- 6 = Ignition coil
